Manhole Inspection Summary

Manhole # S09II1016MH

Insp Date: **5/23/07 11:46 AM**

Location Address: **3503 VIRGINIA AVE**

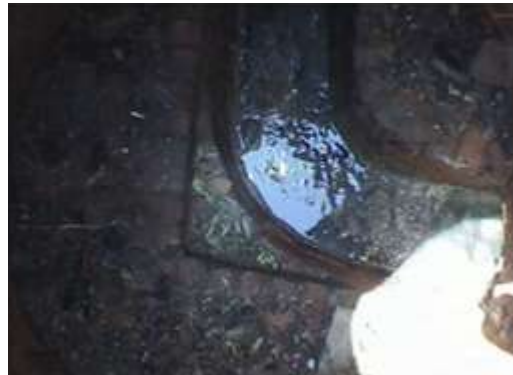
Top View

DEBRIS ON BENCH AND CHANNEL

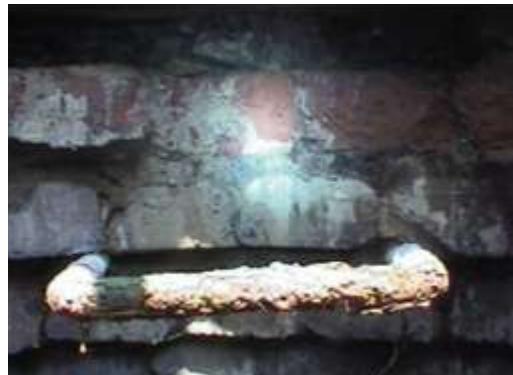
Defect 1

Steps Count: **2** Missing: **0** ☒ **Corroded**

CORRODED RUNG

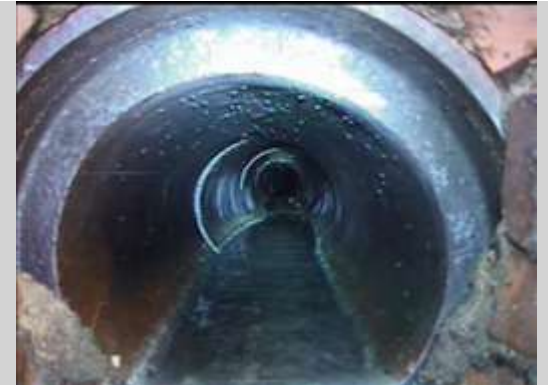
12 O'Clock Outflow

12 in. Circular Gravity Sewer
Pipe Out @ 12 O'Clock

Pipe Height: **13.2** (in.) Rod and Bar (Angled)
Pipe Material: **Clay** ☐ Pipe Lined
Invert Depth: **6.00** (ft.) Flow Characteristics: **Slow**
Deposits: ☒ None ☐ Mud ☐ Sludge ☐ Debris ☐ Grease
Silt Depth: (in.) Deposits Extent:
Infiltration: **None** Pipe Seal Cond: **Sound**

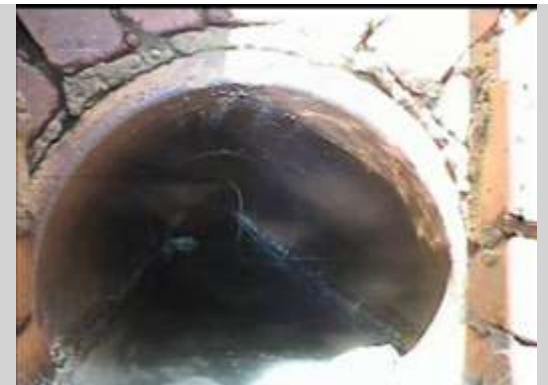
3 O'Clock Inflow

12 in. Circular Gravity Sewer
Pipe In @ 3 O'Clock

Pipe Height: **12** (in.) Rod and Bar (Angled)
Pipe Material: **Clay** ☐ Pipe Lined
Invert Depth: **5.89** (ft.) Flow Characteristics: **Slow**
Deposits: ☒ None ☐ Mud ☐ Sludge ☐ Debris ☐ Grease
Silt Depth: (in.) Deposits Extent:
Infiltration: **None** Pipe Seal Cond: **Cracked**
